Manhole Inspection Summary

Manhole # S35G__031MH

Insp Date: **11/17/08 9:27 AM**

Location Address: **side 201 e baltimore st**

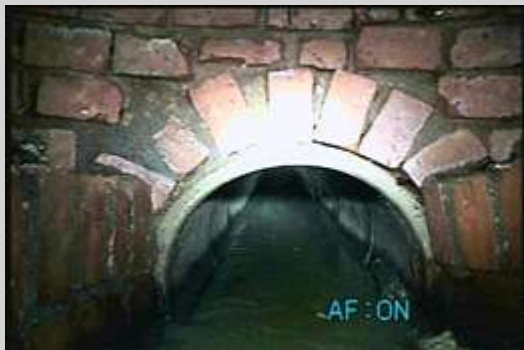
12 O'Clock Outflow

12 in. Circular Gravity Sewer
Pipe Out @ 12 O'Clock

Pipe Material: **Clay** ☐ Pipe Lined

Invert Depth: **23.75** (ft.) Flow Characteristics: **Fast**

Deposits: ☒ None ☐ Mud ☐ Sludge ☐ Debris ☐ Grease

Infiltration: **None** Pipe Seal Cond: **Unknown**

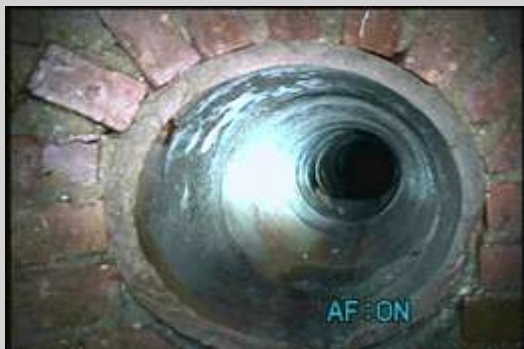
4 O'Clock Inflow

12 in. Circular Gravity Sewer
Pipe In @ 4 O'Clock

Drop In @ 4 O'Clock

Pipe Material: **Clay** ☐ Pipe Lined

Invert Depth: **19.16** (ft.) Flow Characteristics: **Fast**

Infiltration: **None** Pipe Seal Cond: **Unknown**

Drop: **Outside Direct**

Drop Condition: **Open**

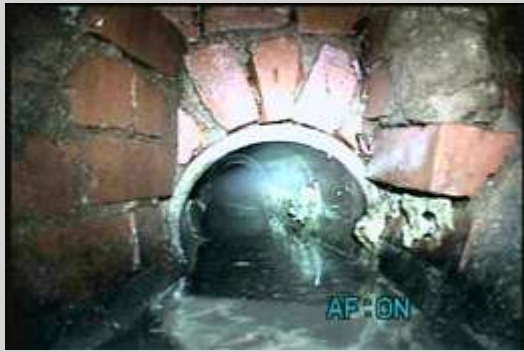
5 O'Clock Inflow

8 in. Circular Gravity Sewer

Pipe In @ 5 O'Clock

Pipe Material: **Clay** ☐ Pipe Lined

Invert Depth: **23.66** (ft.) Flow Characteristics: **Slow**

Infiltration: **None**

Connects To: **House connection / Service line**

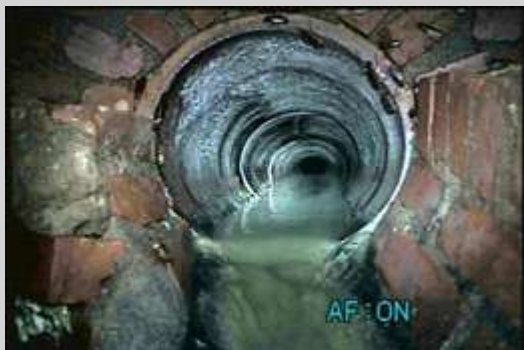
7 O'Clock Inflow

12 in. Circular Gravity Sewer

Pipe In @ 7 O'Clock

Pipe Material: **Clay** ☐ Pipe Lined

Infiltration: **None**
